# Zenair Europe

## Service Letter

| <b>S.L. Number:</b> | <b>ZE-2009-02</b> |
| <b>Subject:</b> | <b>Verification of proper installation of fuselage-mounted “Torque Tube Stop” as per original CZAW drawing 6-B-17CZ.</b> |

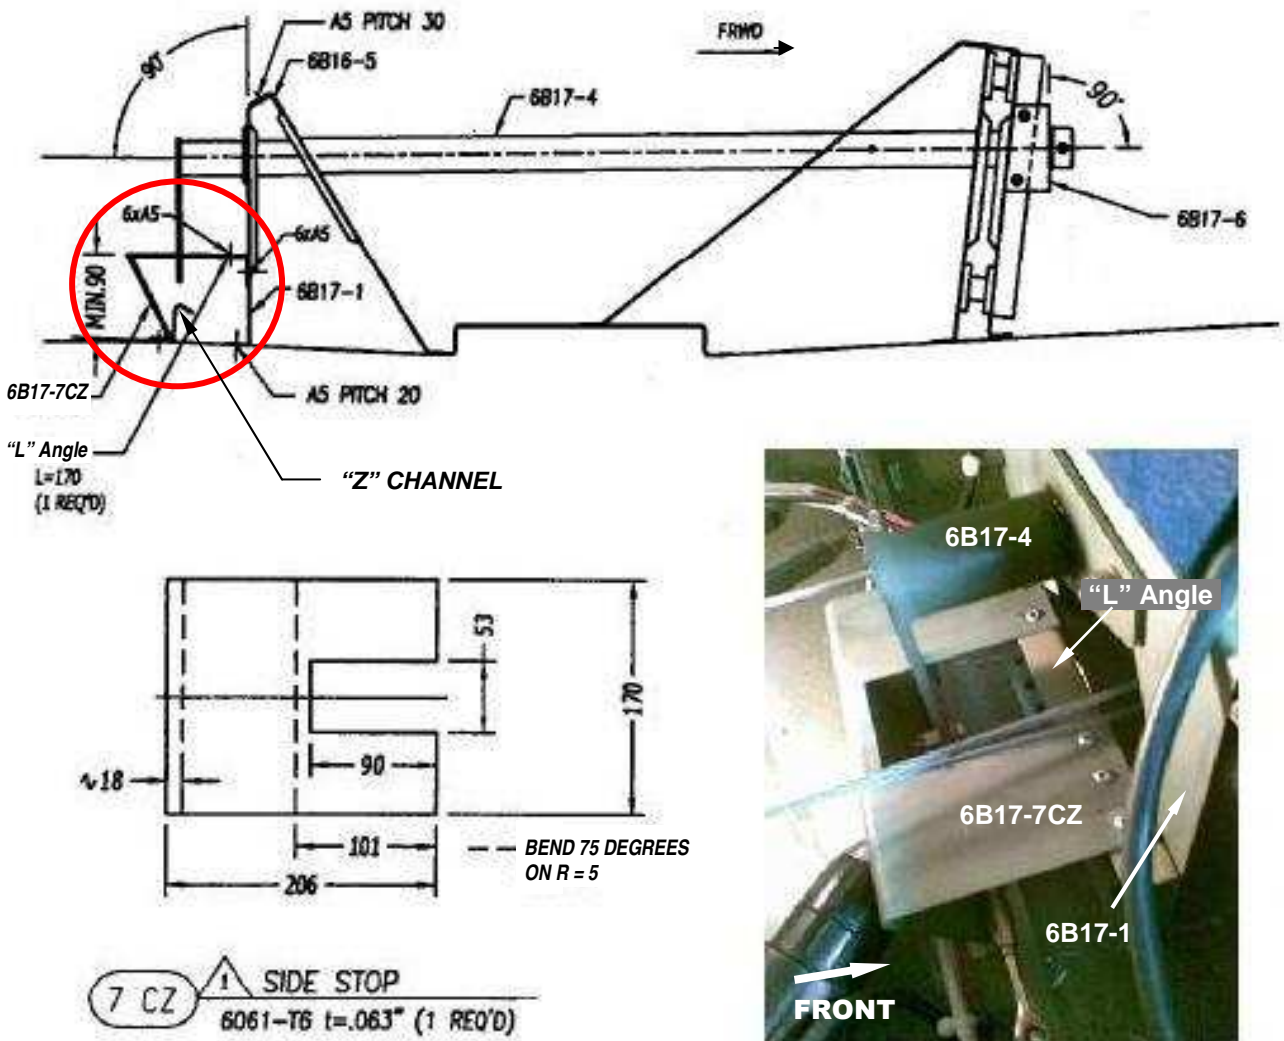
| CZ.A.W.<br>CH 601 XL | CONTROL STICK<br>TORQUE TUBE | 6-B-17CZ | REV.<br>12/2002 |

**Note:** The following Torque Tube stop design was installed by CZAW when the company certified the CH 601 XL to LTF-UL standards. While this control stop is a little trickier to install and weighs more than the wing-mounted aileron stops commonly used today, it protects the control system better from rough hangar handling, high winds when tied down outside, or from exceedingly heavy loads applied to the stick(s) by pilot or passenger when getting in and out of the aircraft. To comply with original LTF-UL certification documents, this Torque Tube Stop is mandatory for German-registered Zodiac aircraft.

**Parts needed:** 1 Torque Tube Stop 6B17-7CZ  
1 Aluminum "L" Angle 6061-T6 (t=.025, ℓ=170mm)  
20 Avex blind rivets Standard "A5"

Access to install this part is through the bottom fuselage inspection door – or behind the seat backs if a bottom door is not available. After checking that all parts match and fit as shown above, install "L" angle to 6B17-1; drill out rivets on bottom "Z" channel and place 6B17-7CZ in position. Check that stick is properly centered and that it contacts the Torque Tube Stop when ailerons are fully deflected (or when they hit the wing-mounted aileron stops). Make adjustments as necessary, then drill holes through "L" angle at the top and back-drill holes from underneath at the bottom. Attach all parts with rivets. Make sure all controls move freely and fully when done. **All parts are available from [www.ULM-Technologie.com](http://www.ULM-Technologie.com) /+33 (0)3 27 33 20 20.**
